Technical Bulletin #14

NATIONAL SLATE ASSOCIATION

Substitute Materials - Comments on NPS Preservation Brief 16

The Use of Substitute Materials on Historic Building Exteriors

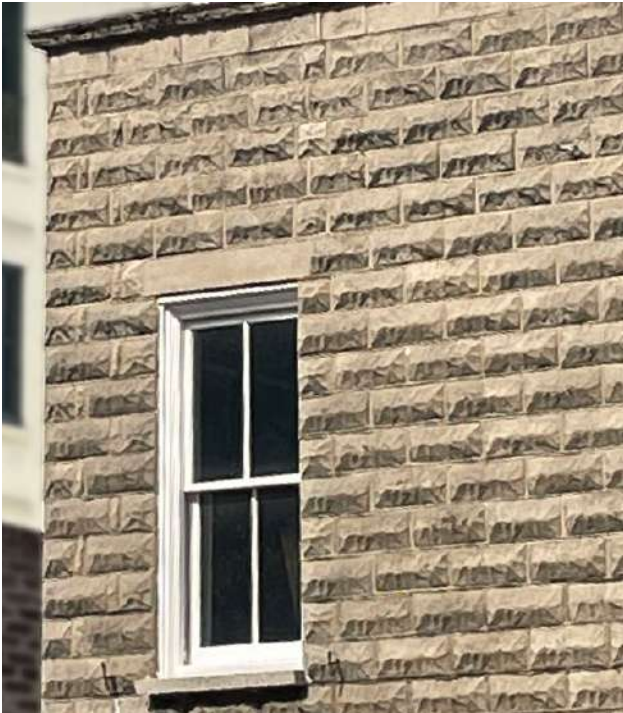
Figure 2a. Casting concrete blocks to mimic quarried stone was a popular late 19th- to mid 20th-century technique. Concrete masonry units could be completed by local craftsman, saving time and shipping costs. Photo: John Sandor, NPS.

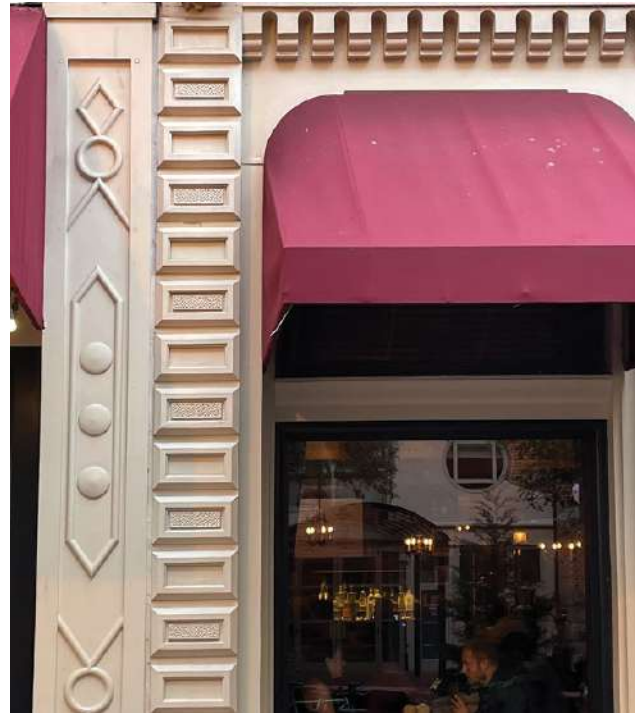
Figure 2b: The 19th century also produced a variety of metal products used to imitate other materials. Across the country, cast iron was used in storefronts to imitate stone. Photo: John Sandor, NPS.

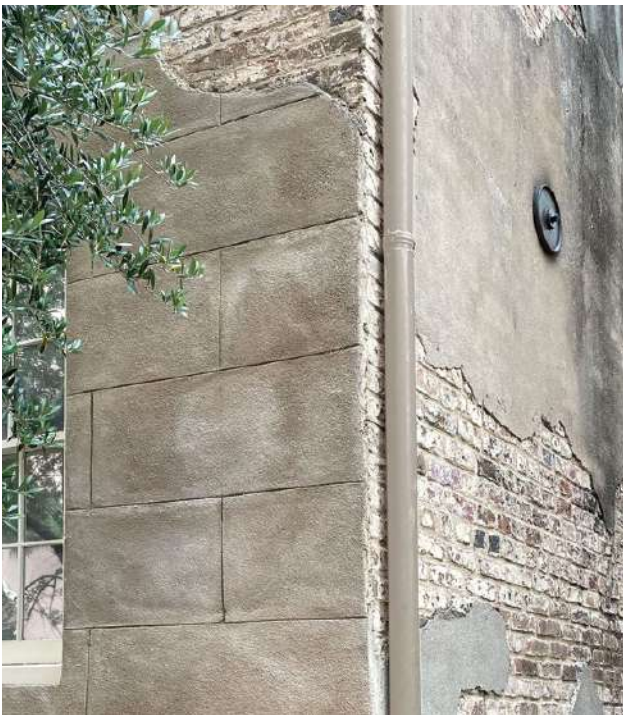
Figure 2c: Stucco has been used to imitate a number of building materials for many centuries. Seen here, stucco was applied to a brick structure and scored to represent a stone façade. Photo: John Sandor, NPS.

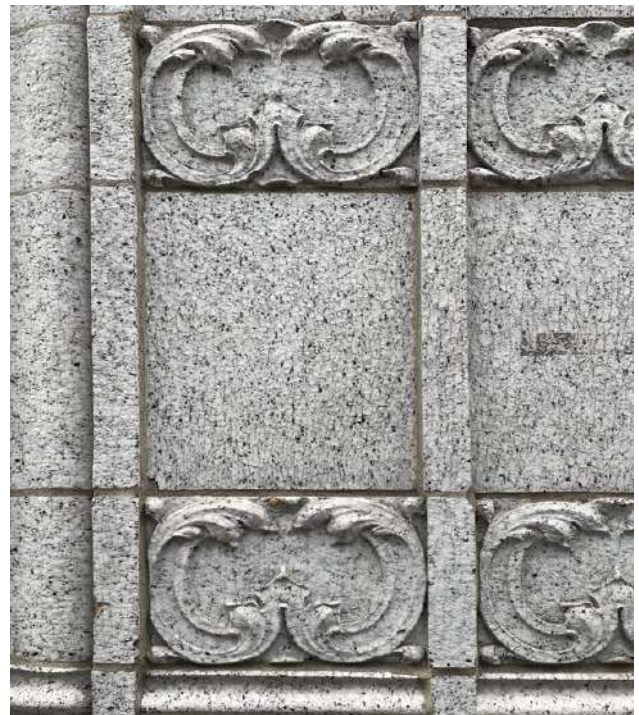
Figure 2d: Terra cotta gained popularity in the late 19th century as a cheap and lightweight alternative to stone. Glazing techniques allowed the blocks to imitate a variety of natural stone materials. Photo: John Sandor, NPS.

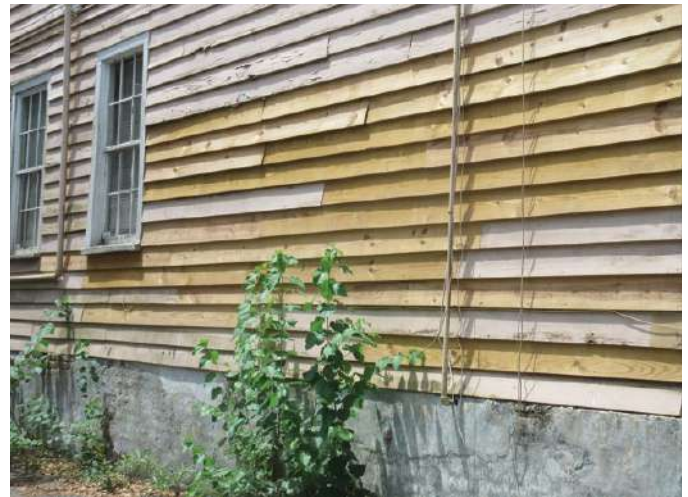
Figure 3: Incremental repair is best done using in-kind material to minimize differences in the performance characteristics that could negatively affect the overall assembly. Photo: NPS.

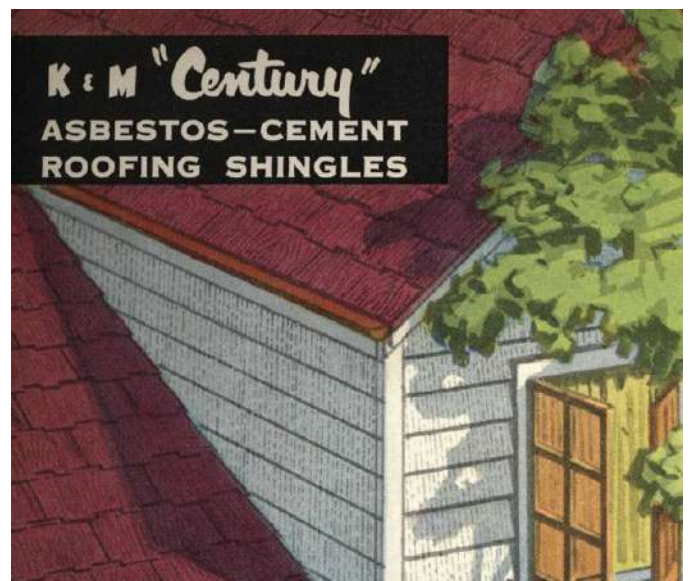
Figure 4. While occasionally used to imitate other materials such as wood or slate shingle, many asbestos shingles and siding materials had their own distinct shape and profile. No longer manufactured today, alternative materials must be found to replace these materials when they are distinctive features on a historic structure. Drawing: Association for Preservation Technology, Building Technology Heritage Library.

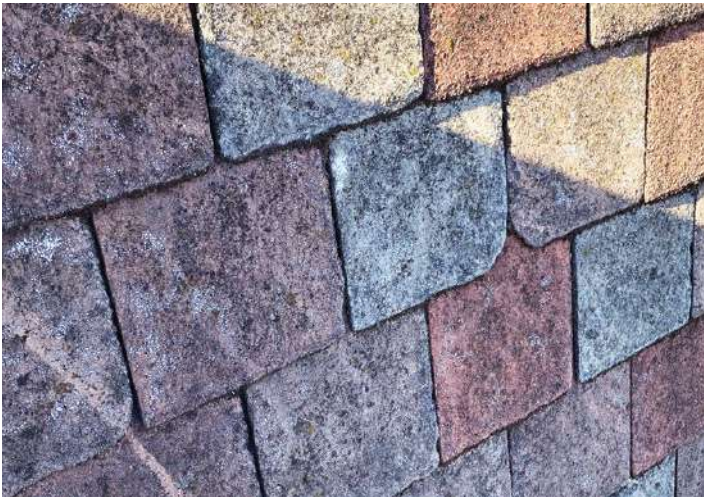
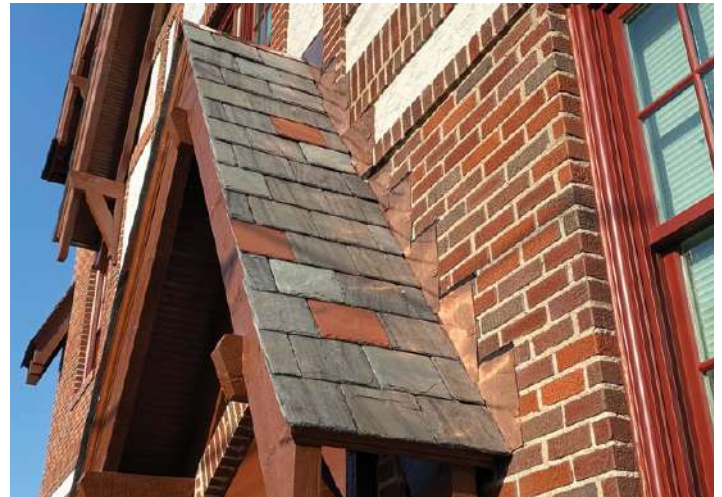
Figure 5. (Left) Asbestos shingles were often used as a substitute for traditional slate roof shingles. The historic asbestos roof on this rehabilitation project had reached the end of its lifespan and required complete replacement. (Right) Given the limited replacement materials available to match the historic asbestos shingles, utilizing natural slate was determined to be the best visual match for the original shingles and design intent in this instance. Photos: Crosskey Architects.

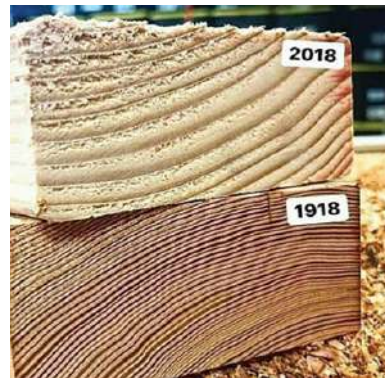
Figure 6. The dramatic difference in the number of growth rings between old-growth wood and wood that was recently harvested from second- or third-growth forests is indicative of the diminished dimensional stability and durability of most lumber currently available. Photo: Zachary Dettmore.

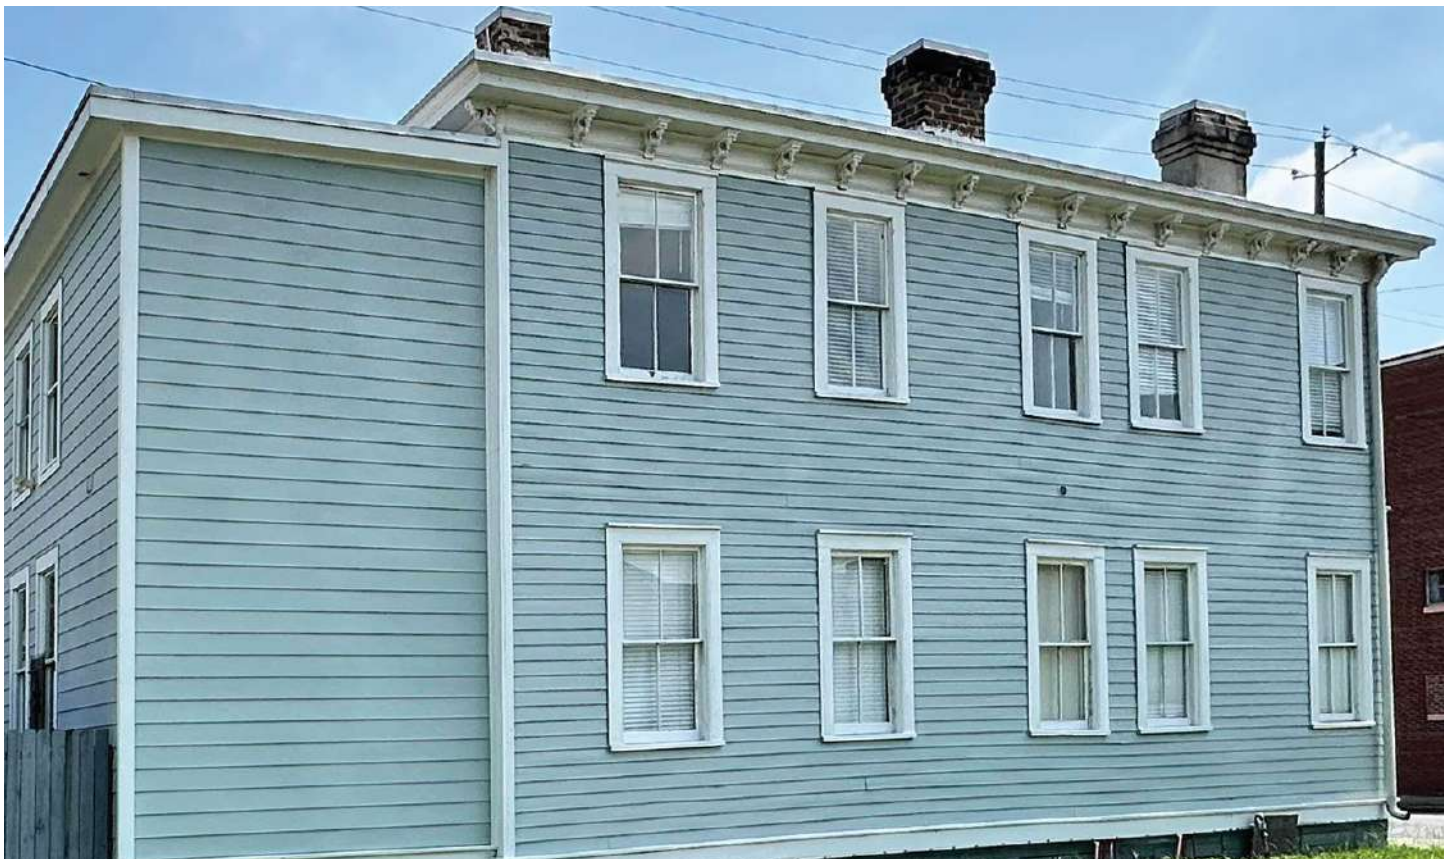
Figure 7. A new addition replaced non-historic construction on the rear elevation of this building. Fiber cement gives the addition a compatible appearance without replicating the exposure for thickness of the historic siding. Photo: Ward Architecture + Preservation.

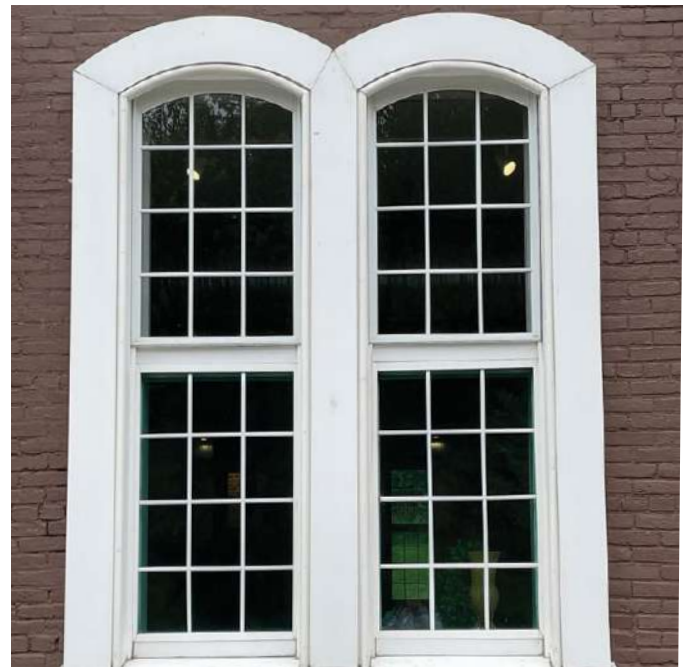
Figure 9. Previously bricked-in openings below the flood line were reopened and new aluminum windows installed with cellular PVC trim detailed to hold back moderate flood waters and survive exposure to water. Photo: John Sandor, NPS.

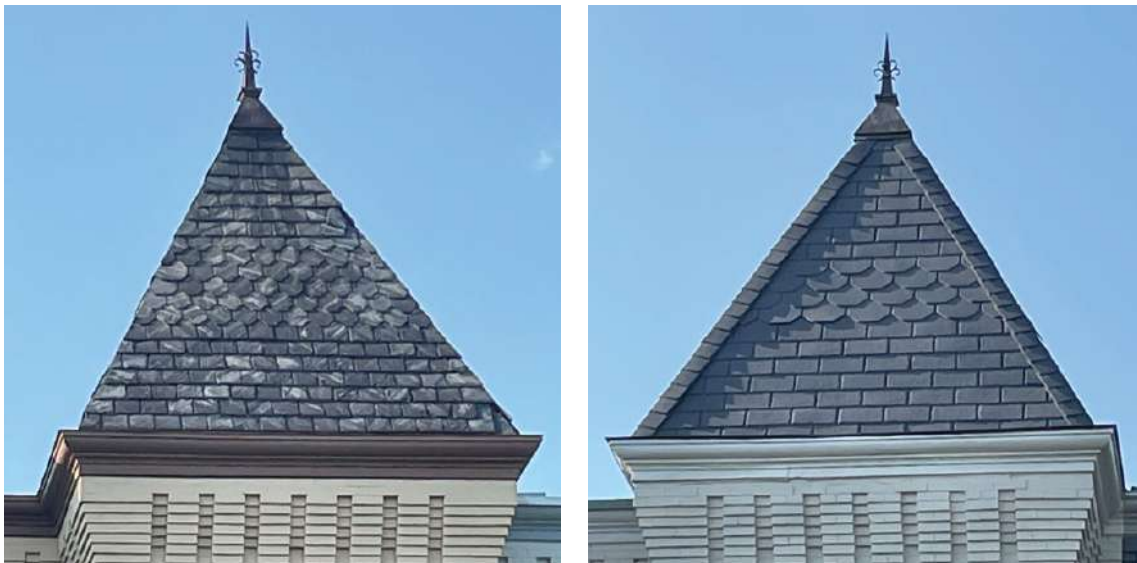
Figure 10. Polymer slates offer a choice of shapes but not sizes, limiting their ability to achieve a good visual match for some historic slate. With the size of the polymer slates (right) being nearly twice that of the historic slates (left), the scale of the entire feature is incompatibly altered. The molded edges of this material, which contribute to its ability to replicate slate, would be lost if each shingle was resized by cutting. Photo: John Sandor, NPS.

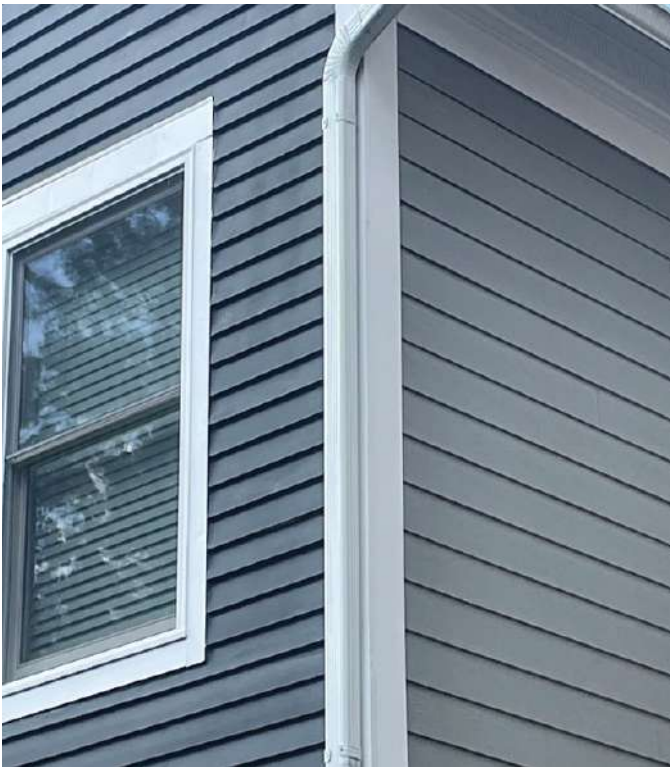
Figure 11. The thickness of the wood siding on the front (left) creates a deeper shadow line than is achieved with the fiber cement siding used on the side (right) elevation. While the exposure can be adjusted, fiber cement siding is not available in a matching thickness. Photo: John Sandor, NPS.

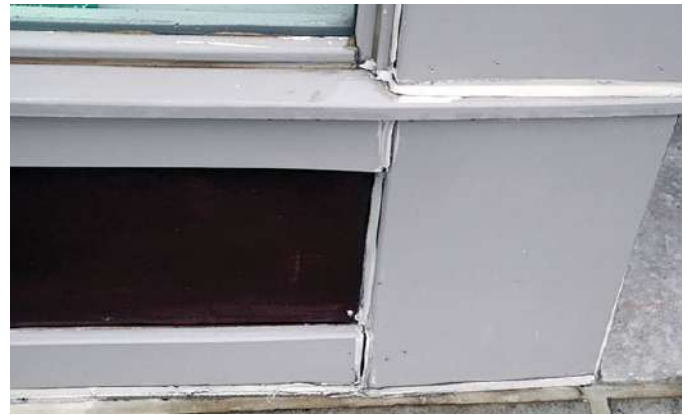
Figure 12. Cellulose composite materials, like wood, expand and contract with moisture. Here it was used to reconstruct a missing storefront. Unlike solid wood that is dimensionally stable parallel to the grain, this composite moves equally in all dimensions, resulting in gaps that were not adequately anticipated in the design. Photo: John Sandor, NPS.

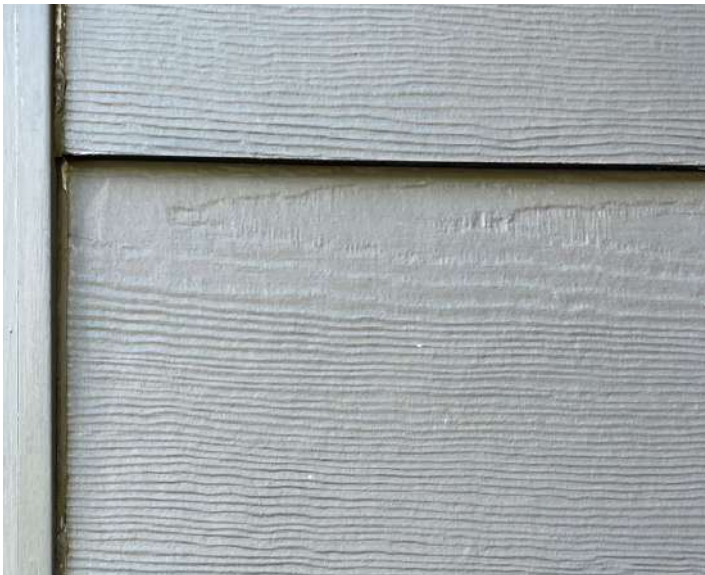
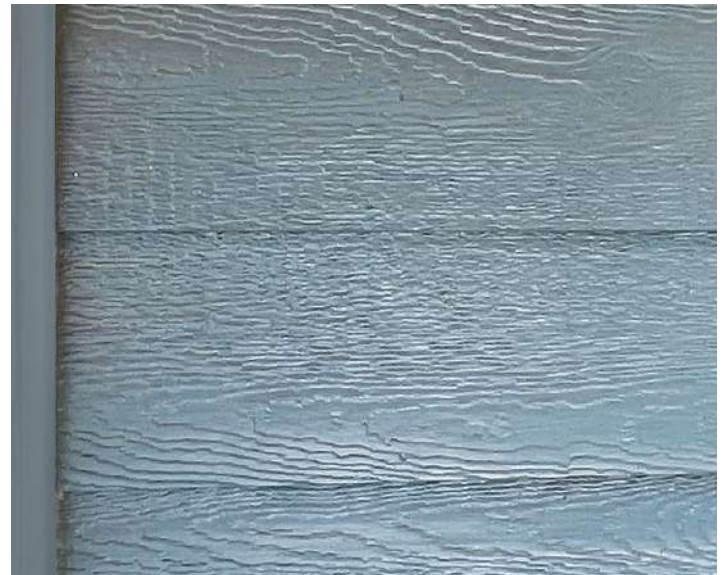
Figure 14. Surface texture is an important aspect in matching the appearance of a historic material, especially when a material is viewed at close range. As seen in these two images, many of the substitute materials produced for siding and trim have an embossed wood grain, making them incompatible for replacing historic wood that was typically planed to a smooth surface. Some substitute products are available with a smooth surface as well. Photos: John Sandor, NPS.

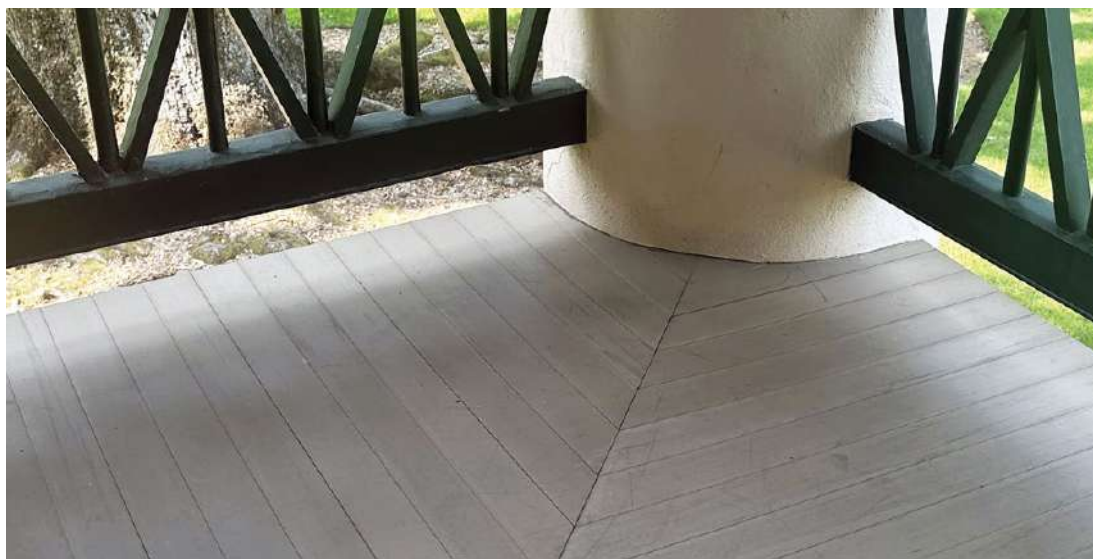
Figure 15. Tongue-and-groove porch flooring is manufactured in several different substitute materials. Each type has different properties, though most are more moisture-resistant than wood. The prefinished product shown can be painted when worn, but repainting is not recommended for some product choices. Photo: Oak Alley Foundation.

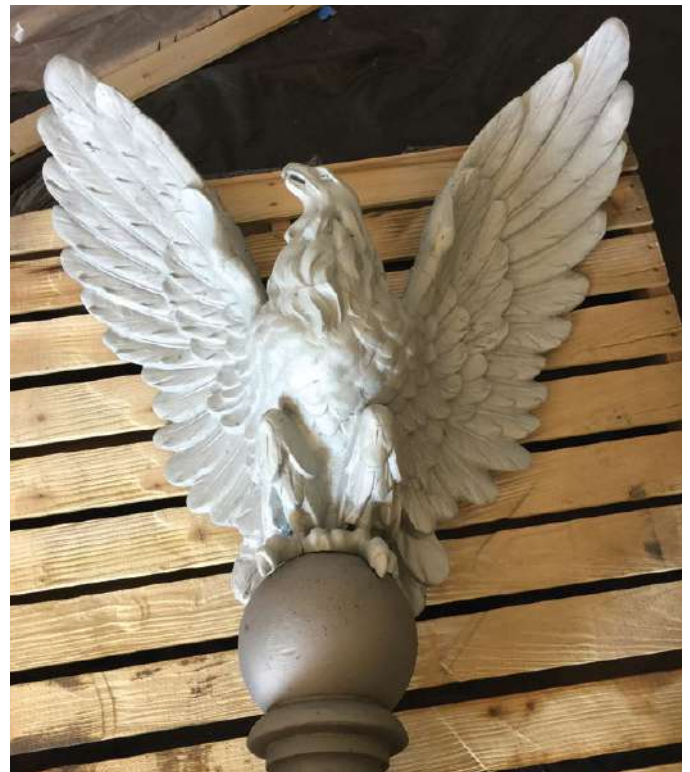
Figure 16. Aluminum is a highly corrosion-resistant metal that is commonly used as a substitute material for cast iron. Aluminum can be a more affordable and lightweight alternative to cast iron that retains a similar texture, shape, and maintenance cycle. Photo: NPS.

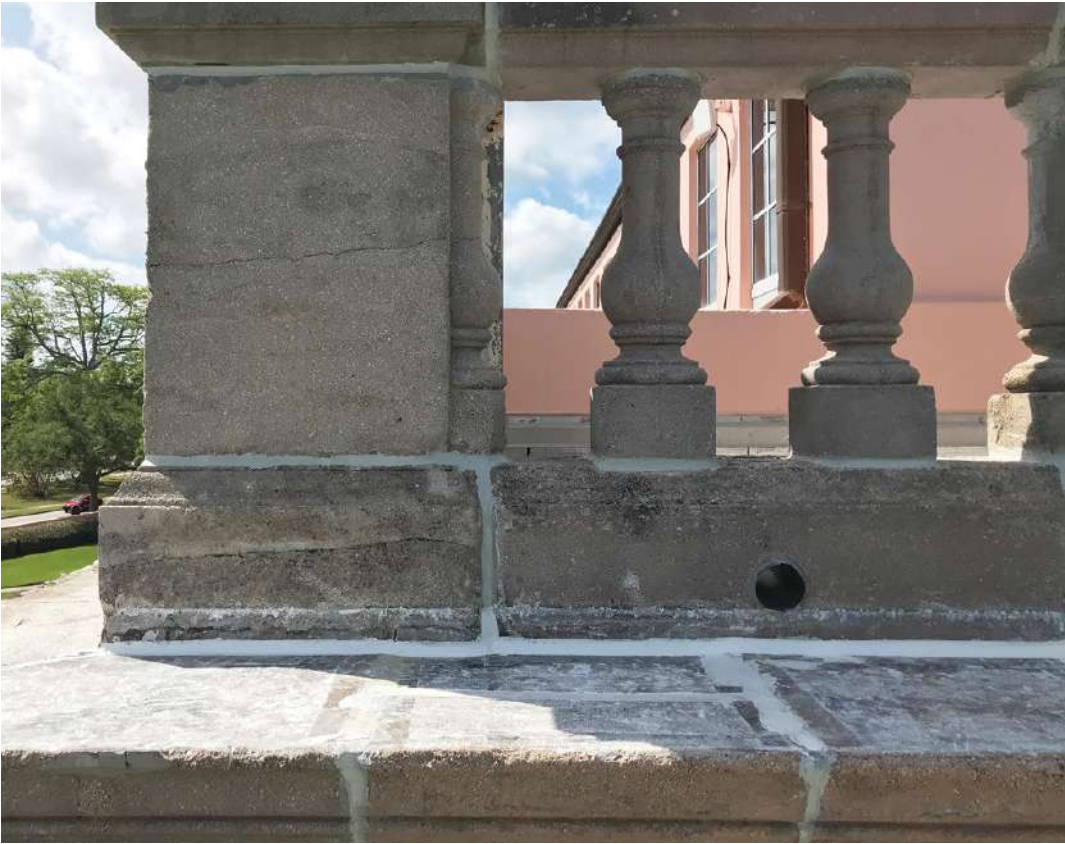
Figure 17. The balustrade consists of multiple prior campaigns of using cast stone to replace the natural stone. The effective match for the surface texture and color of the original stone allowed individual elements to be incrementally replaced only when they had failed, thus retaining the maximum amount of original material as long as possible. Photo: EverGreene Architectural Arts.

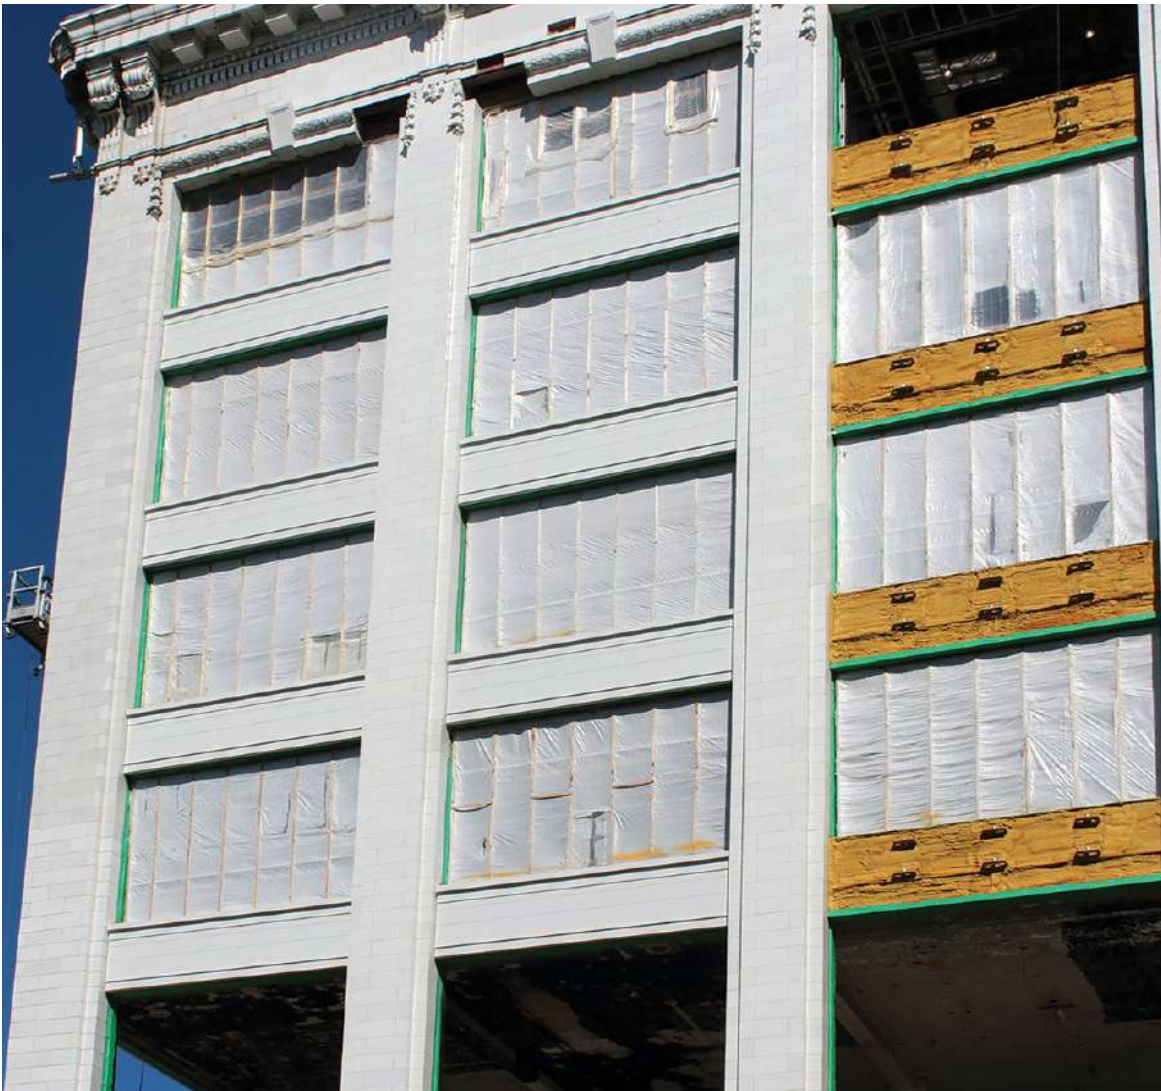
Figure 18. Missing historic terra cotta spandrel panels on all floor levels were recreated utilizing glass fiber reinforced concrete (GFRC) replacements. New spandrels were fabricated as individual components and attached with metal clips between historic terra cotta piers. Photo: Kris Frail, Dewberry.

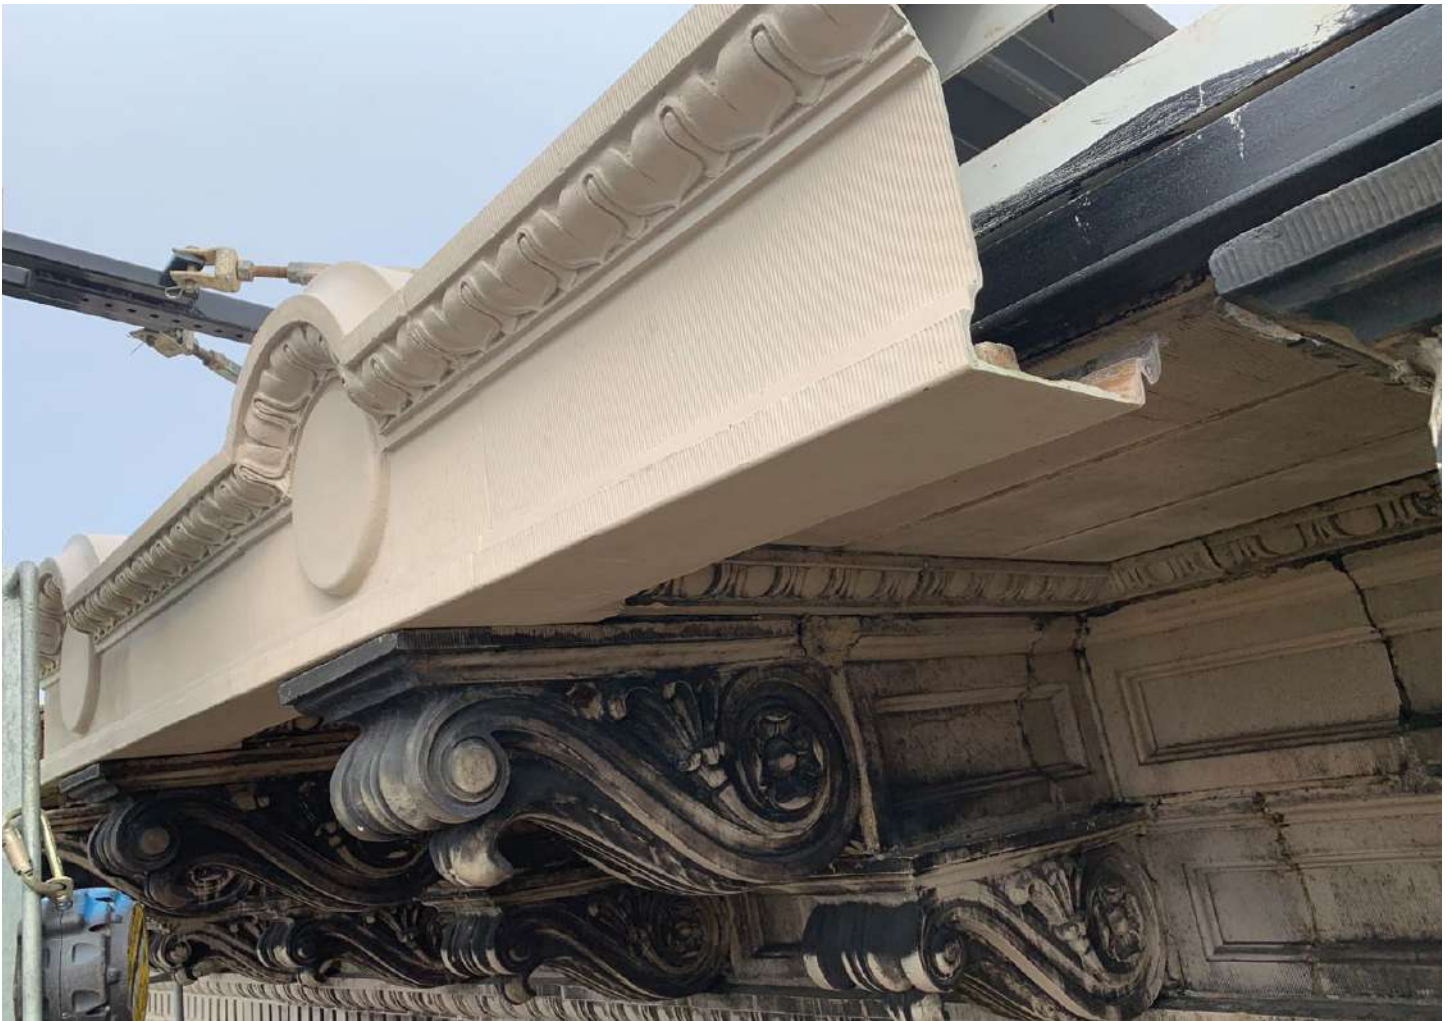
Figure 19. A new, lightweight fiber reinforced polymer is attached to a new metal armature to replicate damaged and missing elements of a terra cotta cornice. Photo: Quinn Evans.

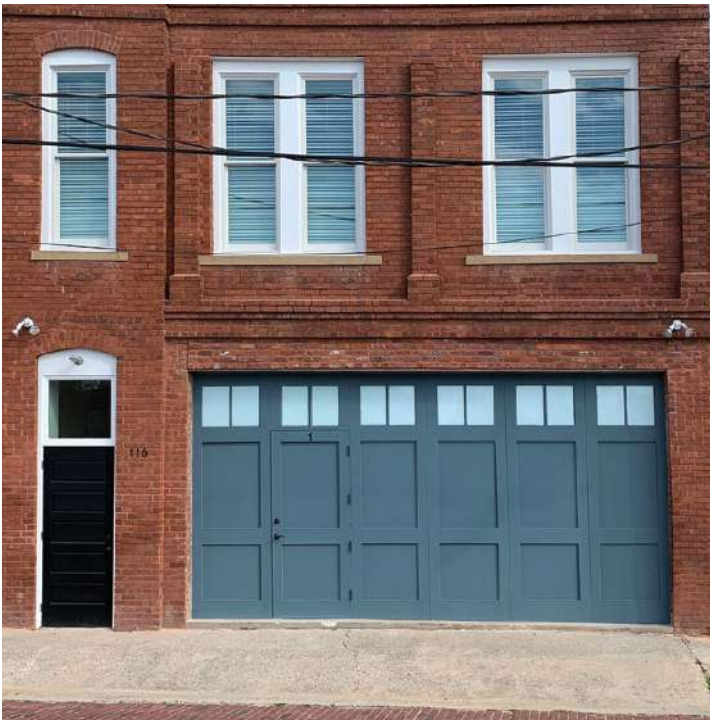
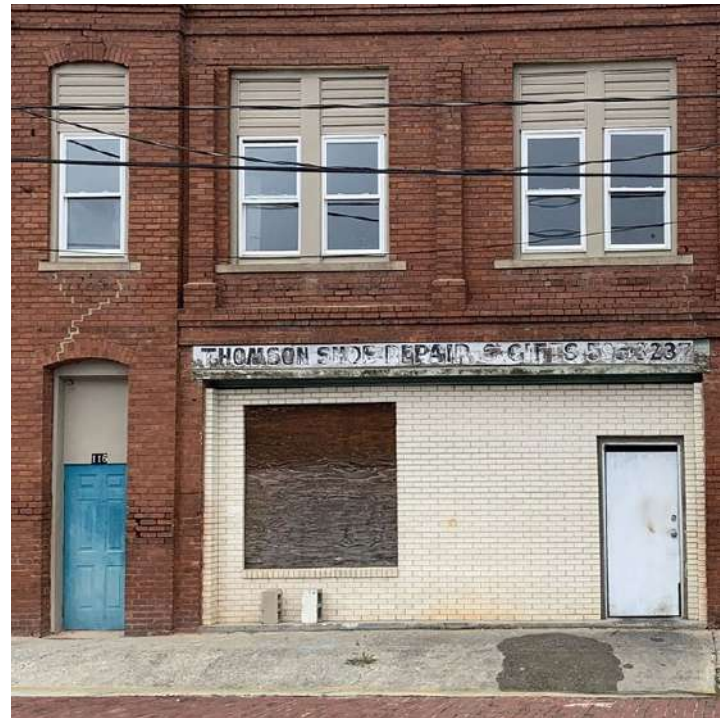
Figure 20. Cement board was used to replace a non-historic infill and mimics the configuration of a typical vehicular door of the period.
Photos: Historic Augusta.

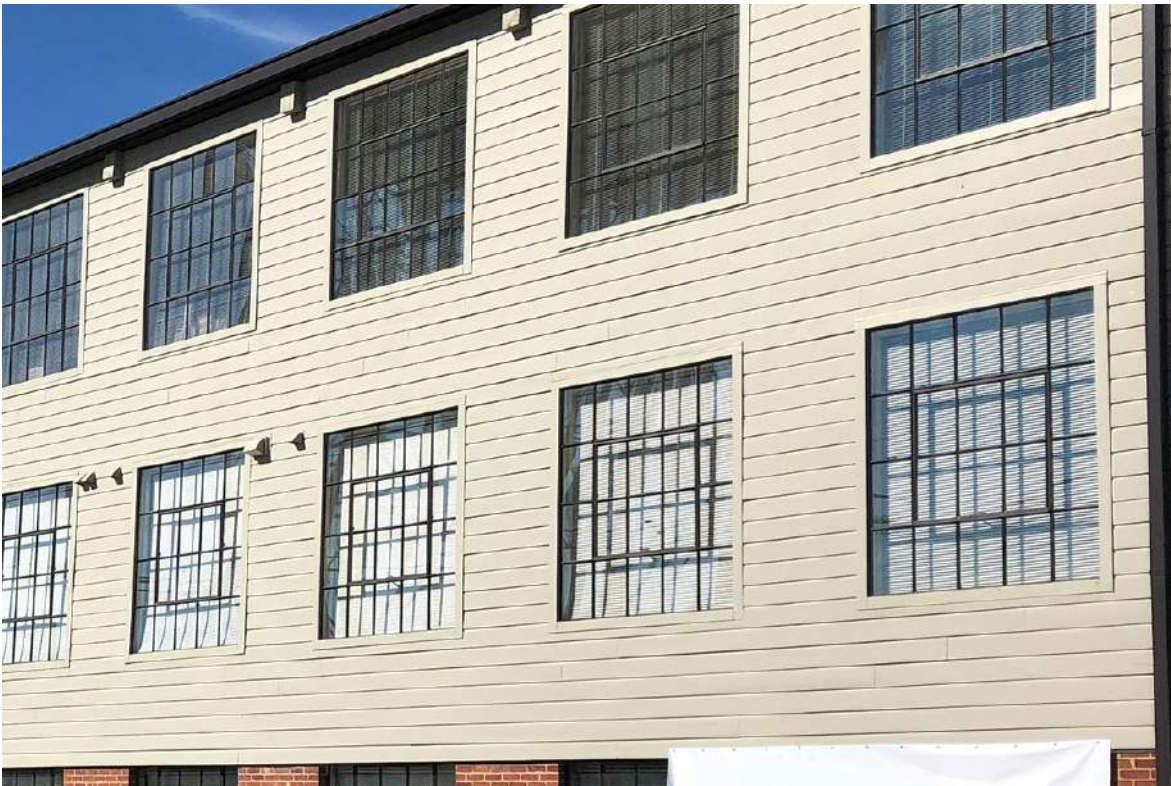
Figure 21. A mineral polymer composite siding was available in the profile very similar to the historic siding. The replacement siding was used where the original material was almost completely missing beneath a more modern covering. Areas where the original wood were largely intact were replaced with matching wood to sustain more of the material integrity of the building. Photo: Belk Architecture.

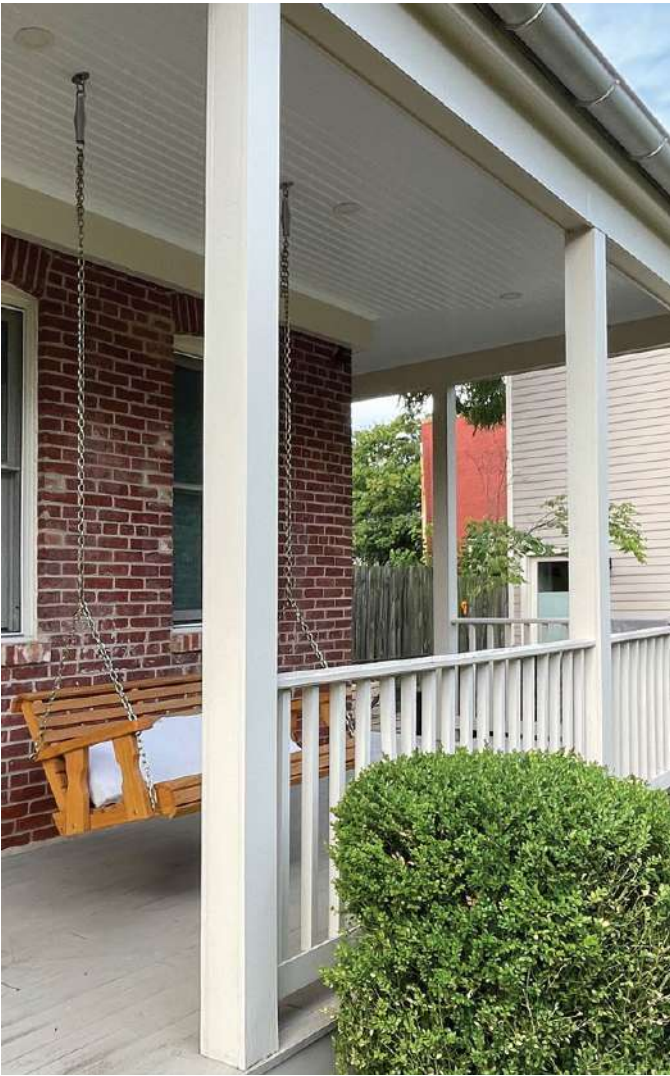
Figure 22. A porch was reconstructed using posts fabricated on site from a smooth-surface cellulose/polymer composite material. Though the face of the posts are painted, the lack of paint on the bottom at the cut ends is not consistent with manufacturers' recommendations. This treatment will allow moisture to be absorbed, shortening the life of the new replacement feature. Photo: John Sandor, NPS.

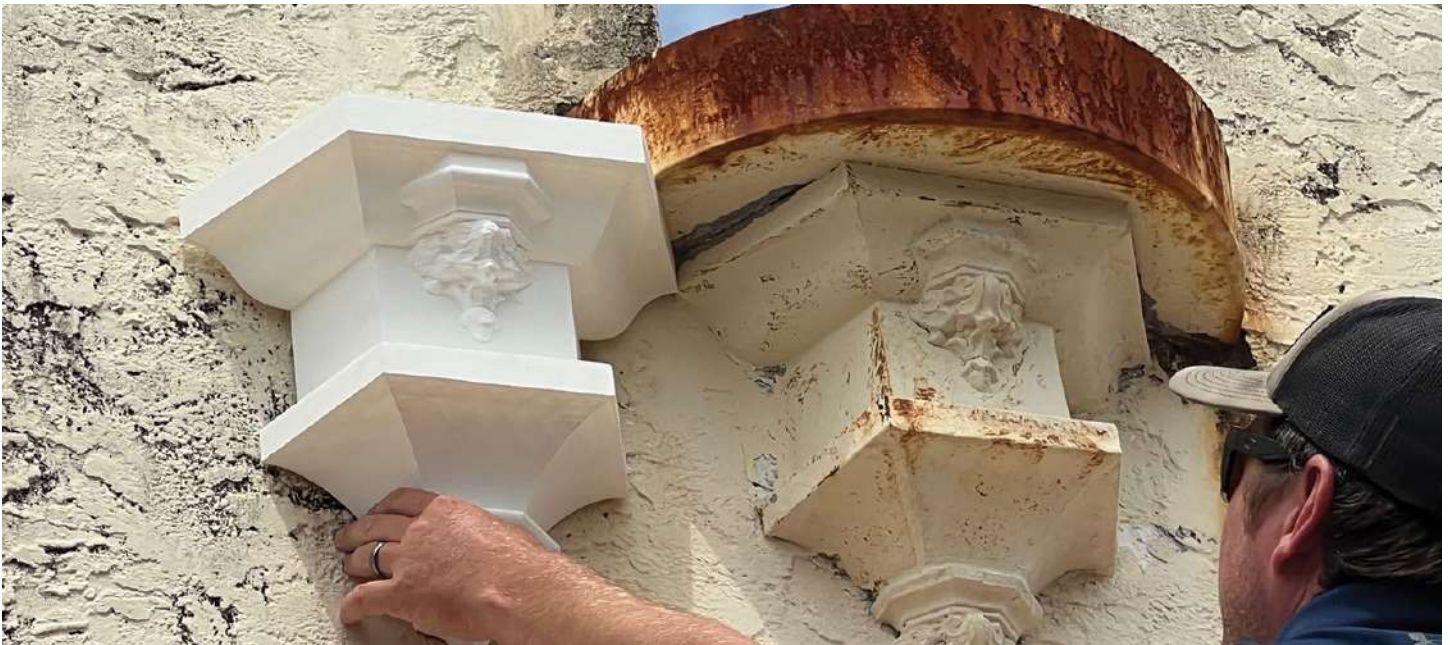
Figure 23. 3-D printing using various polymers is occasionally used to replicate missing metal or wood features. This new application is continually being refined, but the application can be successful when a painted, lightweight feature needs to be replicated. Photo: NPS.

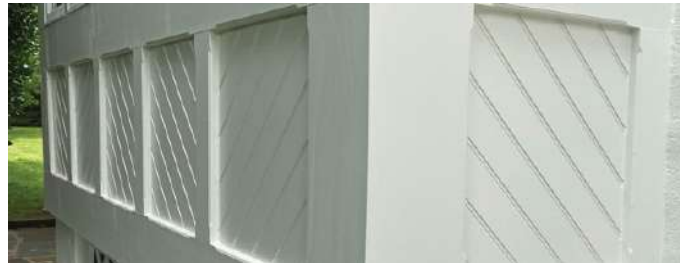
Figure 24. Cellular PVC when painted can be used to replace deteriorated wood features. This beadboard set in a wood frame was not historically designed to shed water effectively and had deteriorated. Cellular PVC was able to match the appearance of the wood details, while its properties were well matched to the shady location, painted finish, and limited size and configuration within the overall assembly; thus, it should provide a long-lasting solution for this application. Photo: Jennifer Balson Alvarez, NPS.
